Manhole Inspection Summary

Manhole # S19G__043MH

Insp Date: **10/1/07 11:25 AM**

Location Address: **32 PULASKI ST**

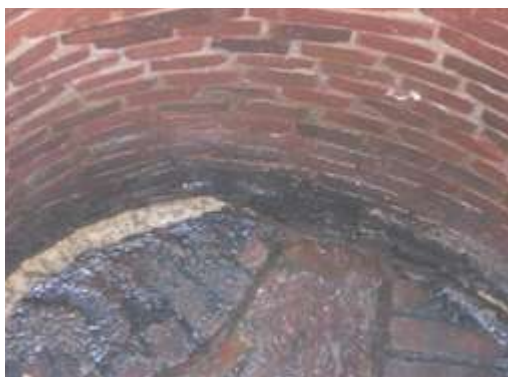
Defect 4

Infiltration: ☐ None ☐ Joint ☐ Cracks ☐ Mortar ☐ Roots ☒ **Wall**

BARREL INFILTRATION

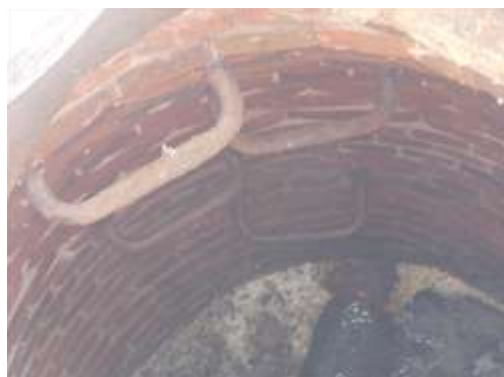
Defect 3

Count: **4** Missing: **0** ☒ **Corroded**

CORRODED STEPS

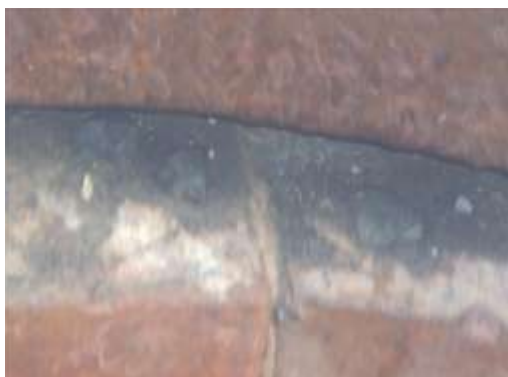
Defect 2

Condition: ☐ Sound ☐ Cracked ☐ Root Intrusion ☐ Loose Brick ☒ **Deteriorated**

CHIMNEY DETERIORATION

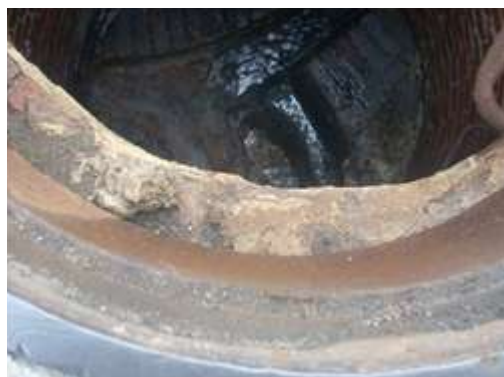
Defect 1

Offset: **2** (in.)

FRAME OFFSET

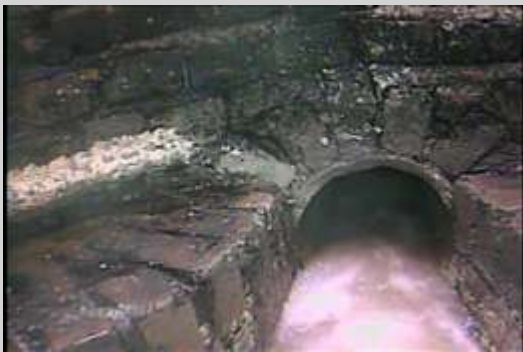
12 O'Clock Outflow

Pipe Height: **8.4** (in.) Rod and Bar (Angled)
Pipe Material: **Clay** ☐ Pipe Lined
Invert Depth: **8.29** (ft.) Flow Characteristics: **Slow**
Deposits: ☐ None ☐ Mud ☐ Sludge ☒ **Debris** ☐ Grease
Silt Depth: **3** (in.) Deposits Extent: **Medium**
Infiltration: **None** Pipe Seal Cond: **Sound**

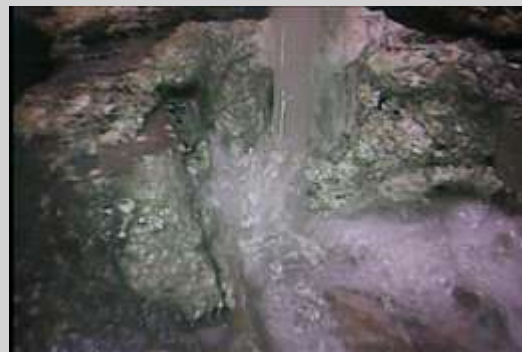
Drop In @ 9 O'Clock

BARREL INFILTRATION

Drop Condition: **Clogged**
